Norbert Holtkamp
Accelerator Systems Division
Division Director

10/14/2003

Over the course of the last week leaks were found in e-beam welds of 3 drift tubes of tank 4. Work was stopped immediately and a detailed investigation lead by LANL (J. Sims) is ongoing. A detailed description from Jim Sims is given in the next two paragraphs. Tank 3 and tank 1 continue to make good progress. As soon as the last parts from LANL (slug tuners and post couplers arrive, installation on tank 1 will continue and conditioning will begin. Preparations for the ARR and begin operation on July 7th are still on track.

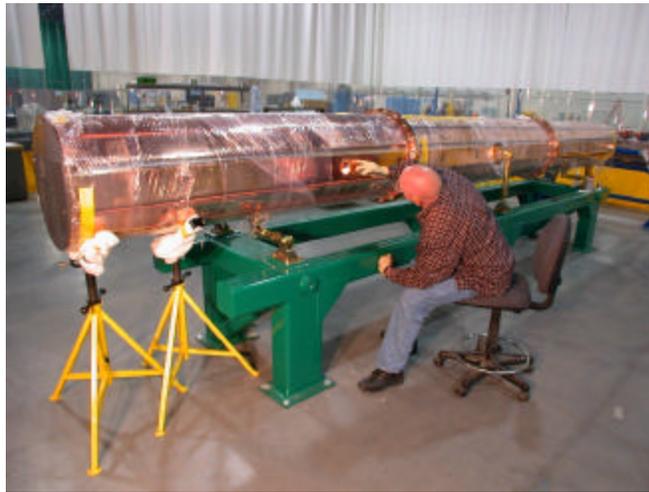
Fig. 1: Tank 4 bolted together in RATS.
